SAFETY AUDIT REPORT

E. I. D. -Parry (India) Limited

SANKLI

ON 23 RD NOVEMBER 2019

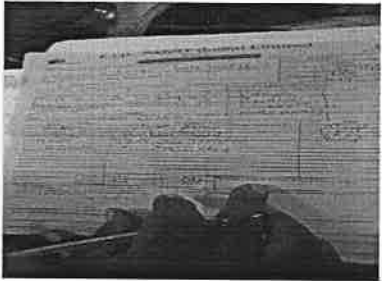
Observation	Recommendation	Photos
1	<p>Work permit system has not been followed</p> <p>Work permit system available but not followed in systematic way while doing maintenance job in 1st mill(Electrical isolation not done , electrical person not sign in the permit)</p>	<p>Work permit system to be followed to avoid the accidents</p>

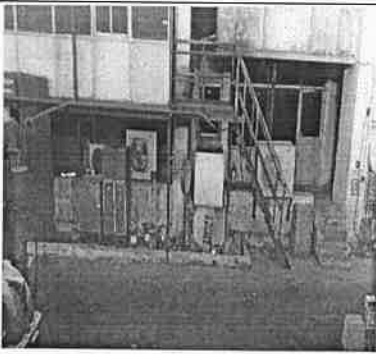
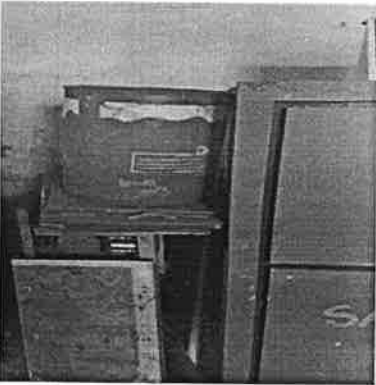
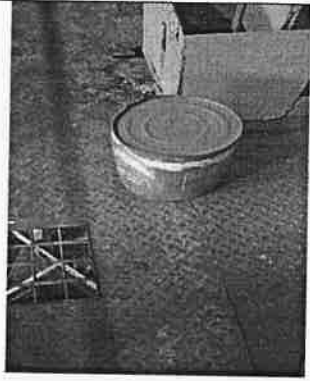
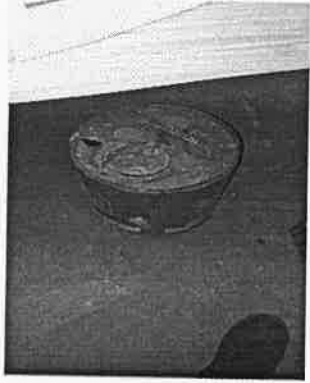
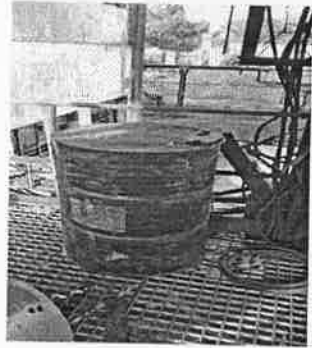
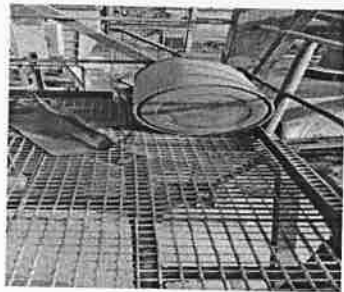
S. No	Observation	Recommendation	Photos
1.	<p>Empty paint tins scattered in many places</p> <p>a) Paint tins in the mill area</p> <p>b) Process area paint tins scattered</p>	<p>As per Hazardous Waste (Management & Handling) Rules, 1989 under the Environment (Protection) Act, 1986</p> <p>The occupier generating hazardous waste has obligation to take all practical steps to ensure that such wastes are properly handled and disposed off without any adverse effect, which may result from such wastes. The occupier shall also be responsible for proper collection, transportation, treatment, and storage and disposal of these wastes either by himself or through the operator of a facility.</p> <p>Empty paint tins are properly collected and disposed</p>

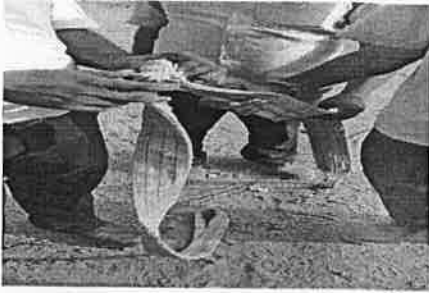
S.No	Observation	Recommendation	Photos
1.	Project materials lifted with damaged belt	<p>Under Section 29(2) of The factories Act 1948 As per rule TNFR -1950 Rule 55A Every lifting machine and lifting tackle in use in a factory shall be thoroughly examined by a competent person and particulars of examination shall be entered in a register in the prescribed Form No. 37 or a report in the prescribed Form No. 37 shall be filled.</p>

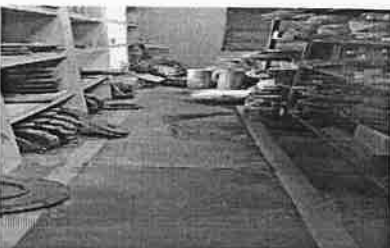
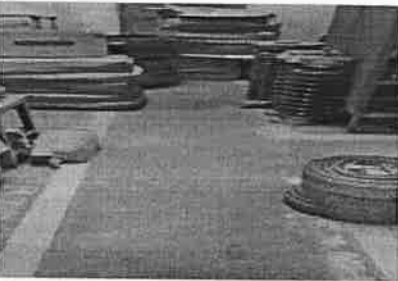
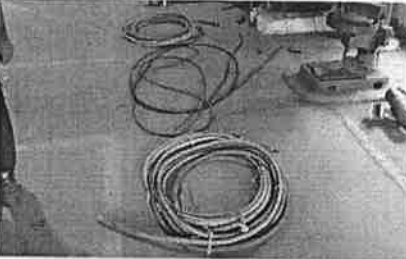
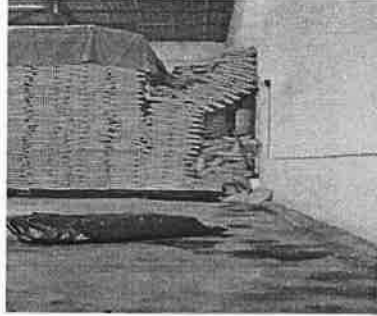
2	<p>Materials in the Hard ware store stacked in the path way</p> <ul style="list-style-type: none"> a) Ear marking found good most of the materials stacked in the path way b) Iron rod stacked over the rack found unsafe c) Material like tube cleaning shaft stacked in the path way found unsafe d) In sugar ware house sugar bag lot found collapsed 	<p>As per OSHA materials handling regulation (29 CFR 1910.176) that covers that "storage of materials shall not create a hazard." this means that containers should be placed carefully "stacked, blocked, interlocked and limited in height so that they are stable and secure against sliding or collapse."</p>

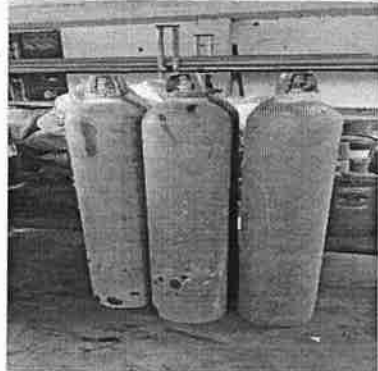
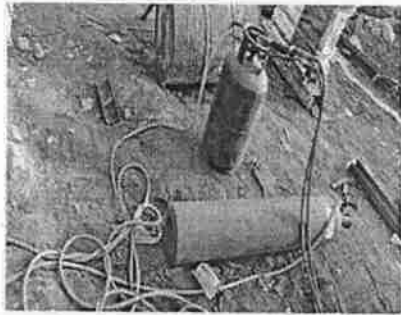
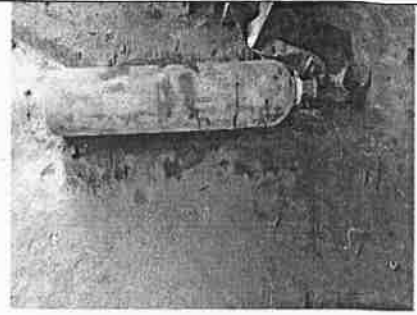
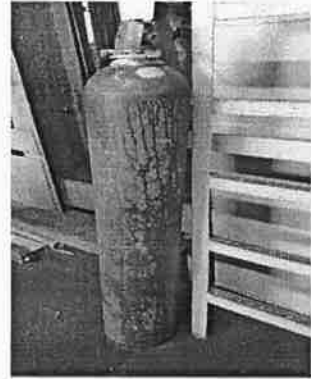
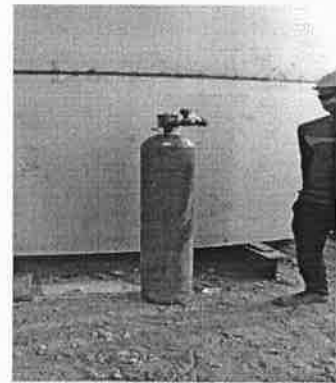
S. No	Observation	Recommendation	Photos
1.	Lose un tied cylinders found in many places	<p>As per Gas cylinder Rules 2004 (18.) Handling and use: -</p> <p>(1) Cylinders shall be adequately supported during handling. (3) The cylinders shall be handled carefully and not be allowed to fall upon one another or otherwise subjected to any undue shock.</p> <p>(4) Sliding, dropping or playing with cylinders is prohibited.</p> <p>(5) Liquefied petroleum gas cylinders and cylinders containing liquefiable gases shall always be kept in an upright position and shall be so placed that they cannot be knocked over.</p> <p>(6) Cylinders used in horizontal position shall be so secured that they cannot roll.</p>

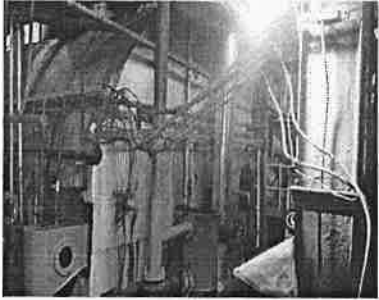
S. No	Observation	Recommendation	Photos
1.	Near vacuum crystallizer lose cables to be corrected	Cables to be laid properly

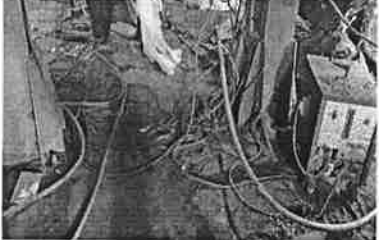
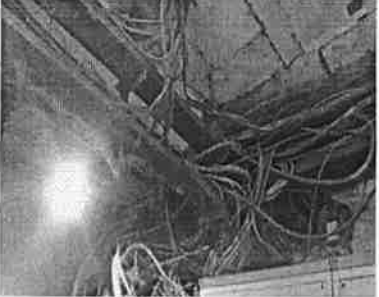
2.	Near co-gen ground floor lose cables to be corrected	Cables to be laid properly

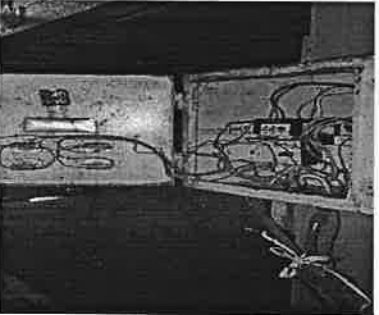
3.	Near boiler area Distribution box to be found open to be corrected	DB to be covered properly

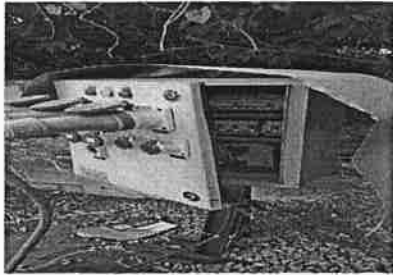
4.	Near project area power distribution box found open to be corrected	DB to be covered properly

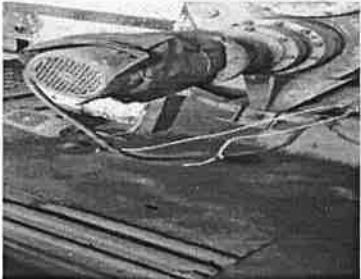
5.	XLR area motor earthing to be corrected

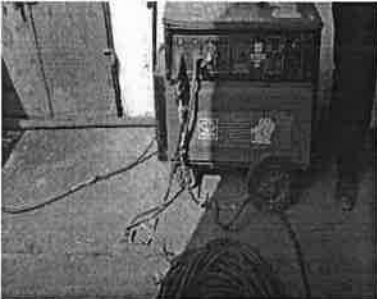
6.	Welding machine cables found damaged , eathing to be corrected

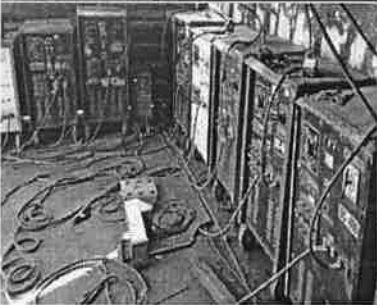
7.	Project area welding machine cables laid unsafe	Cables to be laid properly

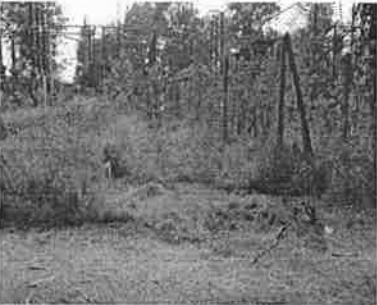
8.	bushes in the switch yard area found unsafe	Bushes to be cleaned

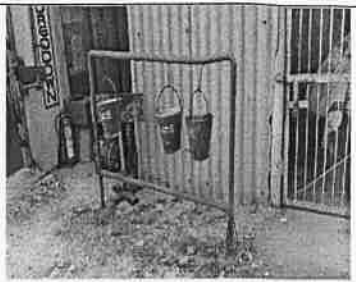
Observation	Recommendation	
1.	In work shop unwanted materials stored in fire bucket

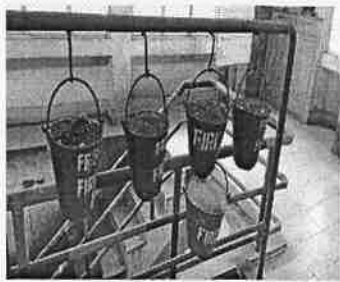
2.	Most of the Fire bucket filled with sand has become hard because not maintained properly	<p>As per the TNFR -1950 Rule 61 (g) All water buckets and pump type extinguishers shall be filled with clean water. All and buckets shall be filled with clean dry and fine sand.</p>

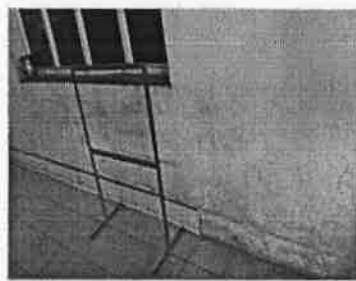
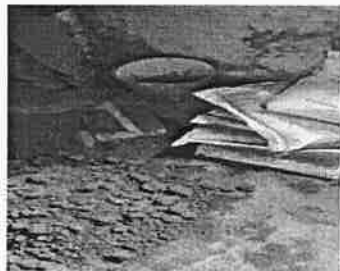
3.	Near Project area fire bucket used for civil work

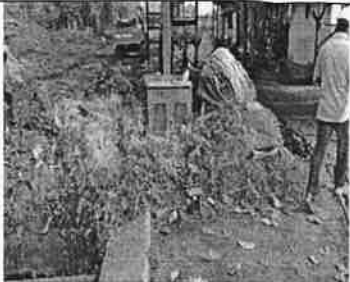
4.	Fire hose boxes are not maintained properly and it is difficult to access	<p>As per the TNFR -1950 Rule 61 –All firefighting equipment shall be placed in a position and shall be readily and easily accessible for immediate use. Generally, these equipment shall be placed as near as possible to the exits or stair landing of normal routes of escape.</p>

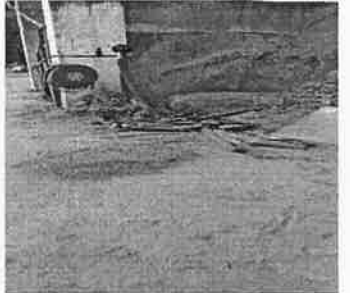
5.	Fire extinguishers periodical checking (inspection and refilling) not done in distillery area	<p>All first-aid fire fighting equipments shall be subjected to routine maintenance, inspection, and testing to be carried out by properly trained persons. Periodicity of the routine maintenance, inspection and test shall conform to the relevant Indian Standards</p>

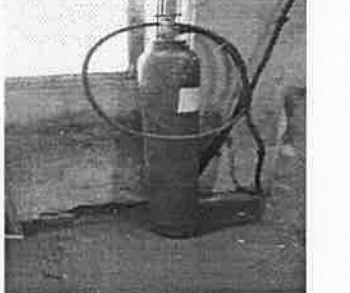
6.	Fire NOC is not getting for Distillery operation	<p>As per the Andhra Pradesh Fire service Act-1999 – section 13(2) The Director general or any member of the service duly authorized by him in their behalf shall within sixty days of receipt of such applications on being satisfied about the provisions of fire prevention and safety measures as stipulated in the National Building codes of India 1983 for time being in force regulating such purpose or activity shall issue a no objection certificate with such condition may be considered necessary and if it not so satisfied reject the same for reason to be recorded in writing</p>

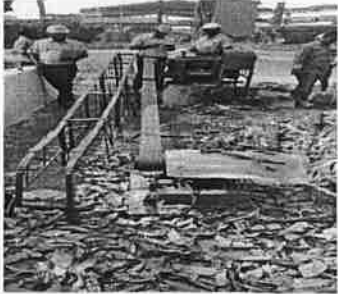
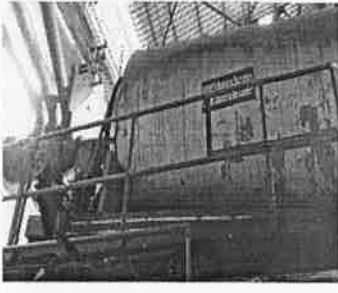
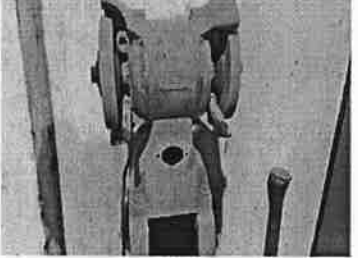
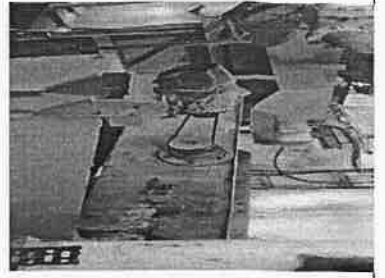
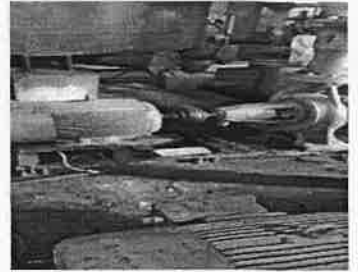
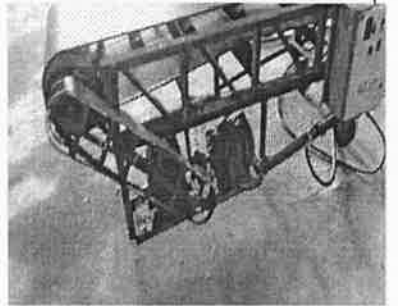
S.No	Observation	Recommendation	Photos
1.	<p>Most of the machine guard found non standard , some motor extension rod guarded , running machinery are not guarded ,</p> <ul style="list-style-type: none"> a) Mini Mill in cane yard guard not fixed b) Rotory drum chain guard guard not fixed c) Xlr motor extension rod cover not provided d) Molasses pump guard not in standard e) Work shop grinding machine guard found damaged f) Co gen feed water pump coupling guard not fixed etc., g) Conveyor chain guard is not standard 	<p>As Per The Factories Act -1948 – section 21 –in every factory every moving parts of prime mover and every fly wheel connected to a prime mover shall be securely fenced by safeguards of substantial construction which shall be constantly maintained</p>

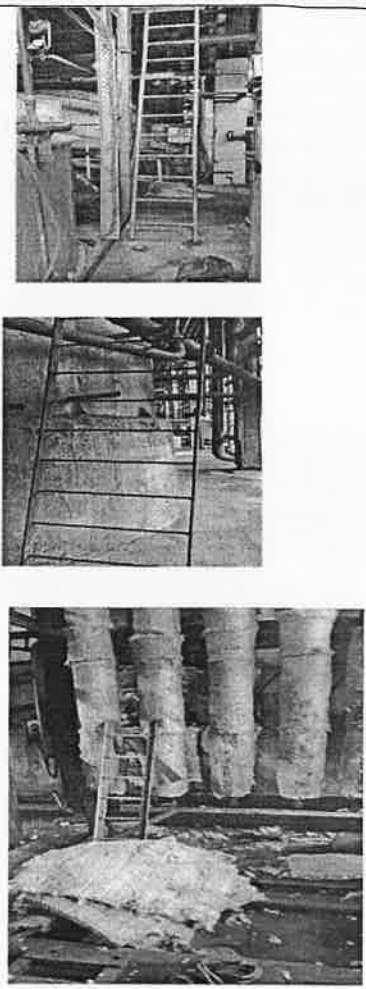
S.No	Observation	Recommendation	Photos
1.	<p>Most of the ladders not provided with hand rail and some ladder are made by using non standard items.</p> <p>cable tray used instead of ladder for insulation work</p>	Access ladder to be provides as per Indian standard 3696 –part -2-1991

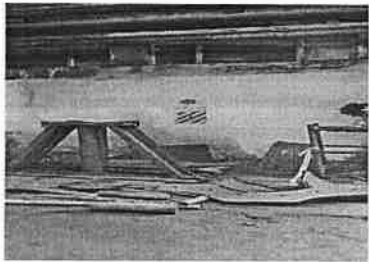
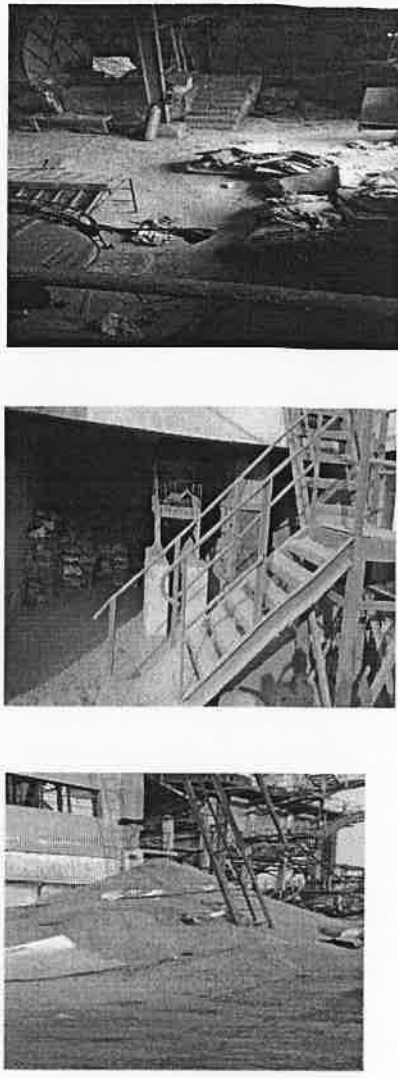
S.No	Observation	Recommendation	Photos
1.	<p>Many unwanted materials kept in walkway.</p> <p>Scrap materials accumulated near last mill</p>	Walkway to be kept clean.

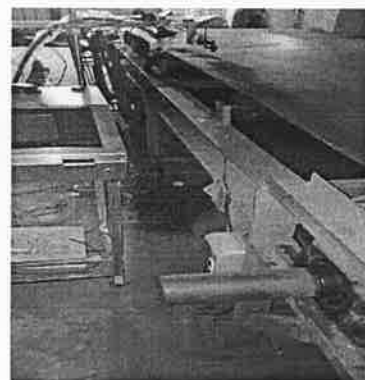
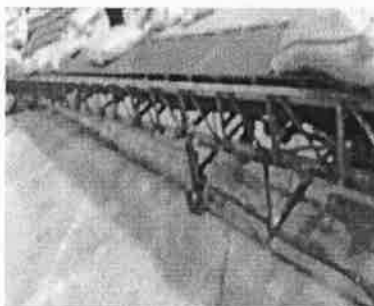
Some of the conveyor found without pull cord switch arrangement

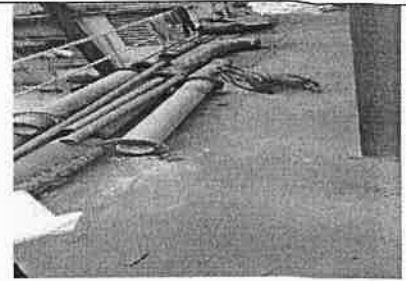
So2 gas line stacked near burner area

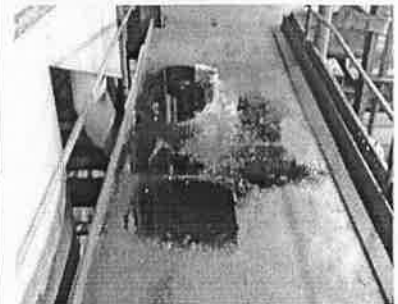
Pan floor area plat form found slippery condition

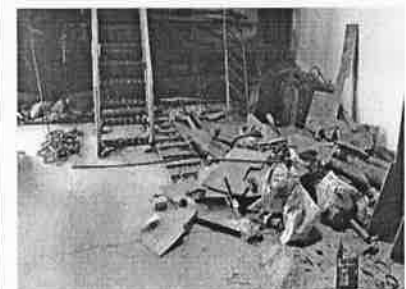
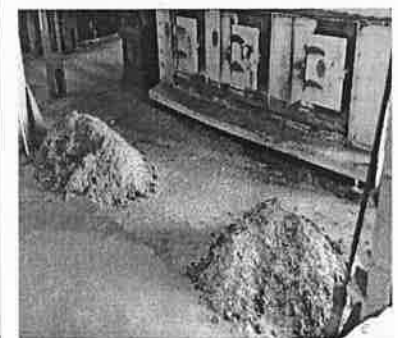
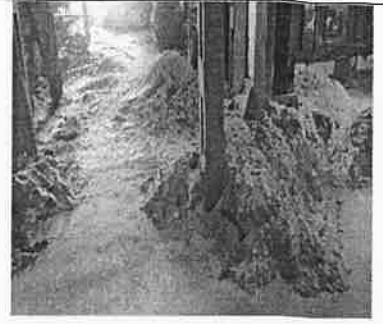
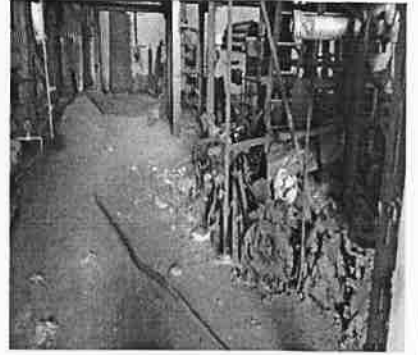
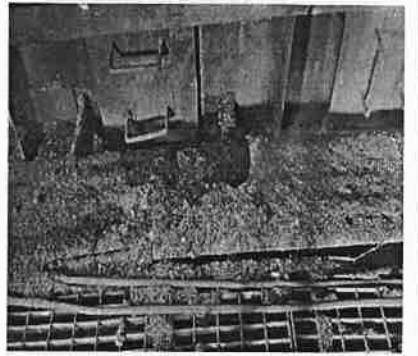
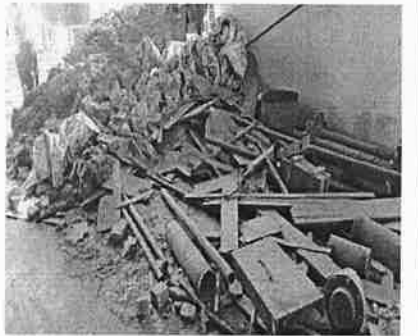
Total co -gen plant housekeeping found very poor condition

All side of boiler all the combustibile materials such as bagasse , wood, insulation material etc., accumulated
